## Field notes on some Broadland churches in the Wroxham area, Norfolk.

Ruth Siddall, January 2019.

*The building stones of Broadland Churches visited by Ruth Siddall and Tim Atkinson on 12 January 2019.*

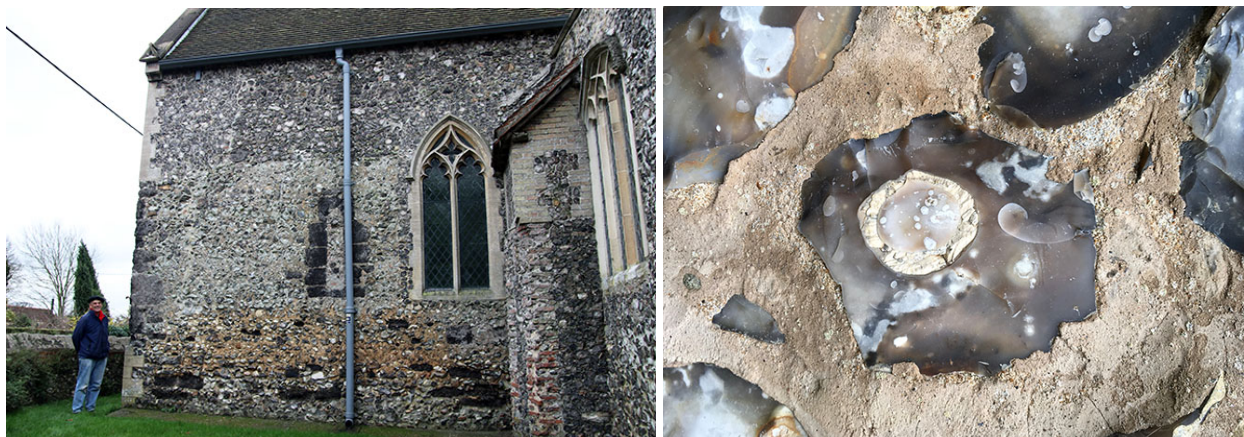
*Left: North facing wall of St Peter's Church, Belaugh showing several phases of construction and restoration and the distinctive, almost black blocks of ferricrete. Right: Knapped flints from the south facing wall containing a *Conulus* sp. Echinoid.*

Ferricrete (very dark brown – almost black, pebbly [angular, moderately sorted], friable and rarer pieces of rust-red pebbly variety, with stratified pebbles). The dark ferricrete is used for quoins on NE corner and for (filled) window dressings on the north wall and as squared blocks in the lower part of this wall. These are probably from the 12<sup>th</sup> Century phase and the ferricrete blocks are possibly reused. Ferricrete blocks have developed a pale green-white encrusting limestone.

19<sup>th</sup> Century – Knapped flint work with Ancaster Stone dressings. Uncoursed, coarse flint with cortices. Some *Conulus* sp. echinoids. Some coursed, square-knapped flint work on buttresses.

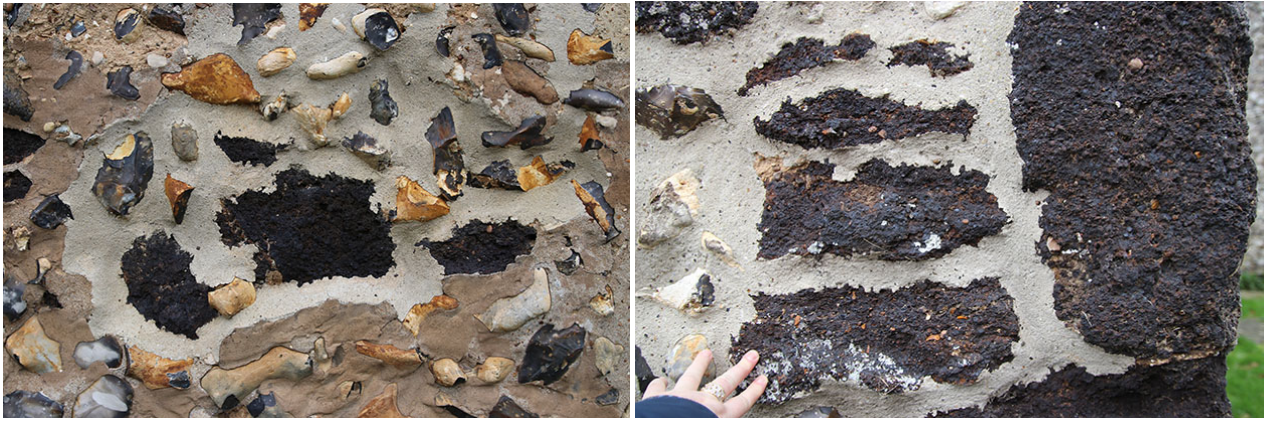
*Left: Blocks of ferricrete along with unknapped, uncoursed flints in the south wall of St Peter's Church, Belaugh. These stones have been recycled into restoration phases. Right: Ferricrete used as quoins and ashlar on the NE corner of the church.*

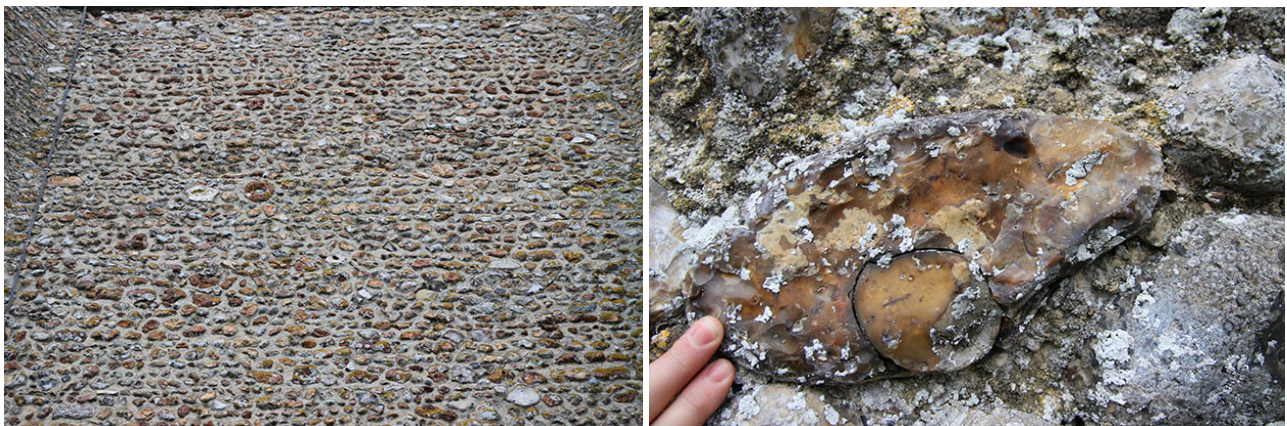
*Left: Red-stained flints on the tower at St Helen's, Ranworth including a ring-shaped paramoudra from the local chalk. Right: red-stained flint with fossil echinoid.*

Flints – coarse with intact cortices, some knapped. Probably some are field flints. Upper parts of the building, including the tower have a large amount of red-orange flints. A circular, red flint in the tower (south side, c. 12 m up) is a paramoudra. Square, knapped, coursed flint work on foundations and buttresses.

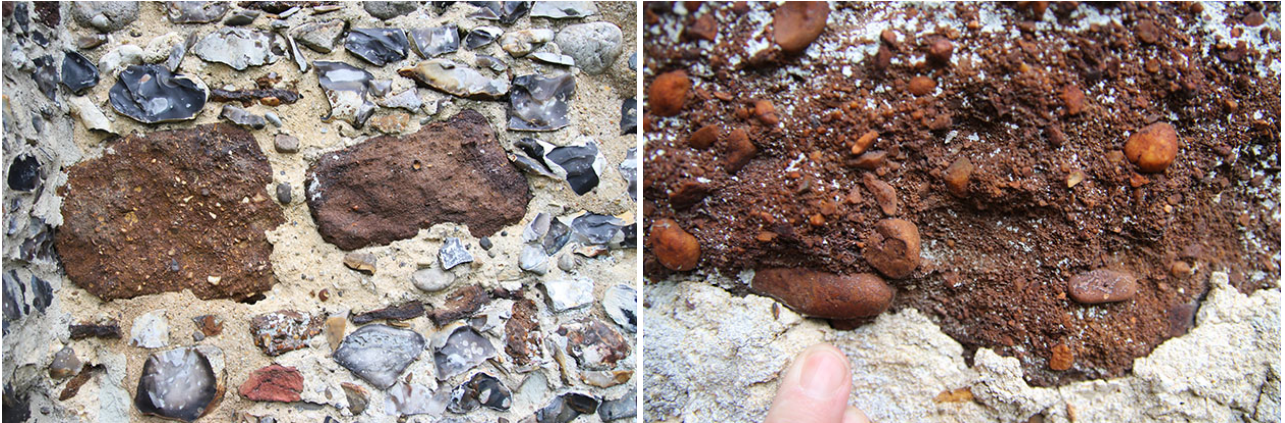
*Left: Blocks of ferricrete at St Helen's Church, Ranworth. Right: the stone has variable texture and clast size/distribution. However, it is notably a bright. Brick red in colour.*

Ferricrete is a bright orange red cemented gravel with rounded to sub-rounded, poorly sorted, flint pebbles up to 4 cm long axis. Some blocks are of a gritty sand with sparse pebbles.

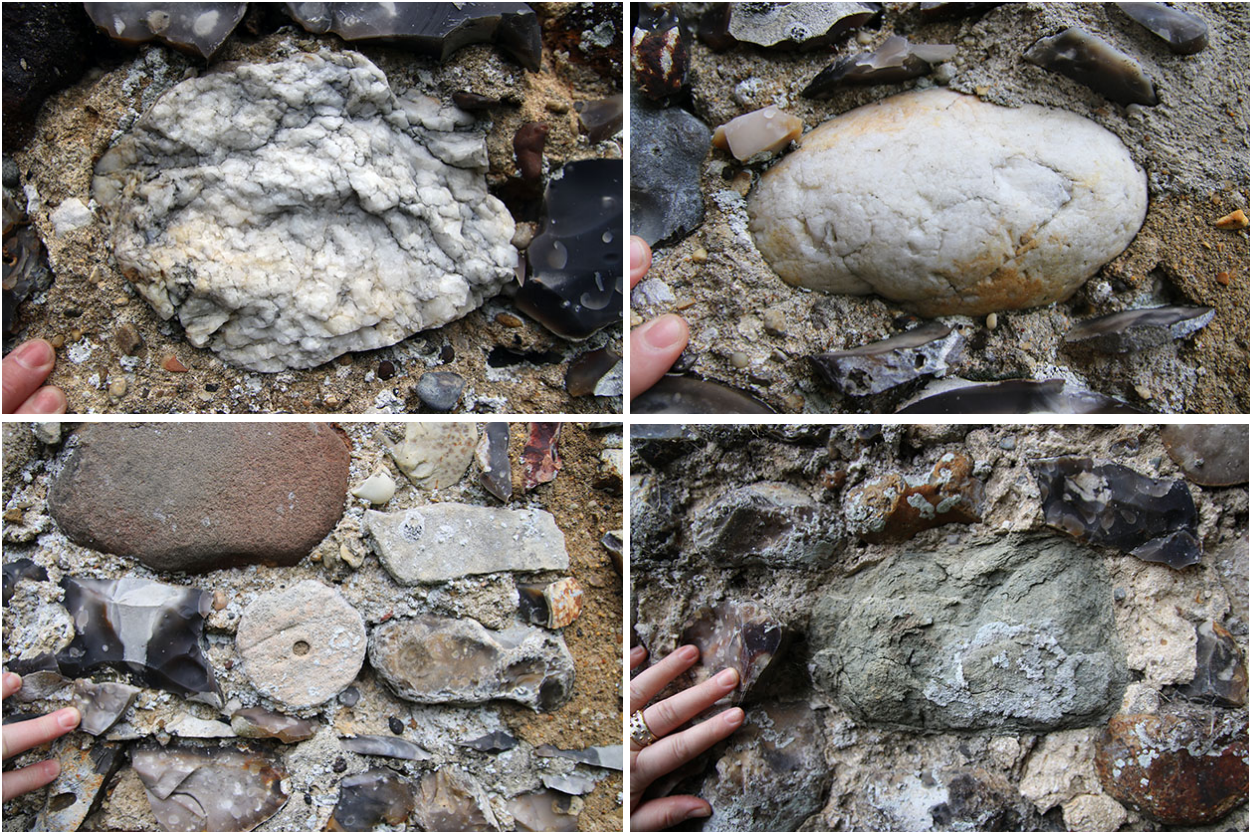
*Top left & right: Vein quartz cobbles from the Wroxham Crag at St Helen's, Ranworth. Bottom left: small pillar of Caen Stone spolia. Bottom right: Greensand block, probably spolia or ballast.*

Wroxham Crag component: cobbles of vein quartz and red-pink Triassic Bunter pebbles (fist size) are common within the fabric, as are rounded, chatter-marked beach flints.

Spolia: a few rough fragments of Barnack Stone and a fine-grained Caen Stone pilaster. Greensands (possibly Kentish Rag) occur in a few squared blocks. These are possibly spolia or ballast.

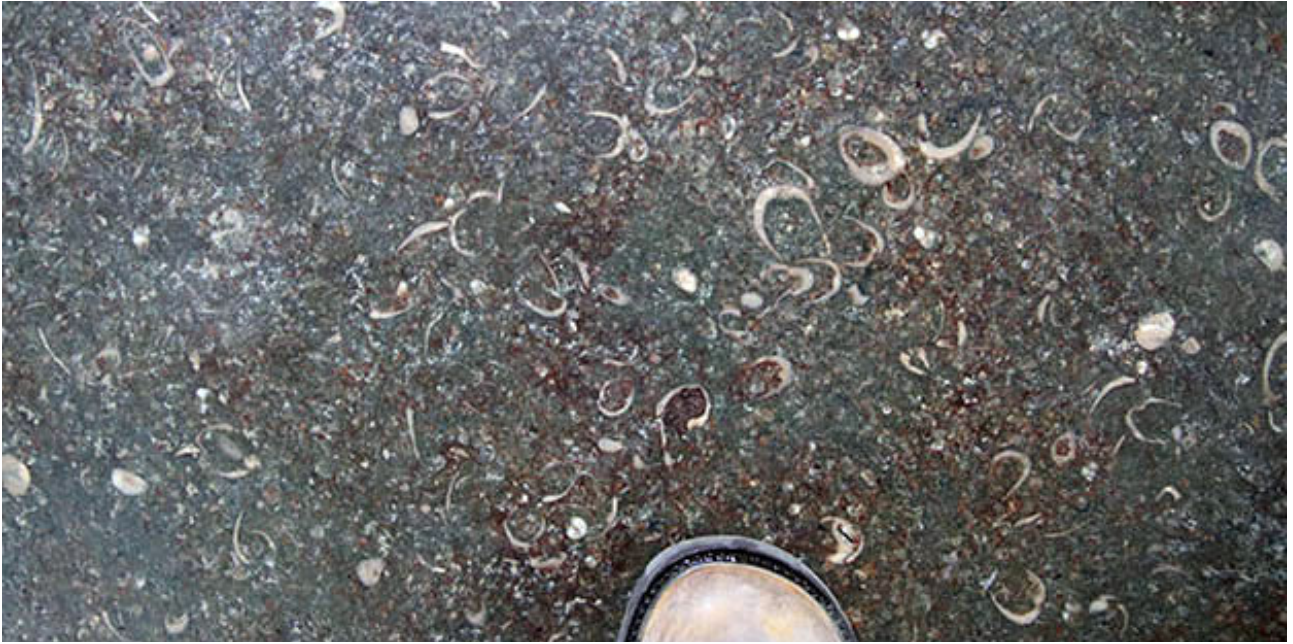
*Above: Green Purbeck Marble grave slab with thick walled, Unio sp. Bivalves inside St Helen's Church, Ranworth.*

Interior: grave slab of Green Purbeck Marble (with *Unio* sp.) flanked by smaller slabs of Red Purbeck Marble. Also slabs of 18<sup>th</sup> Century of black Lower Carboniferous limestone with small white rugose corals, sparse brachiopods and a gastropod. This is probably Belgian or Irish in origin.

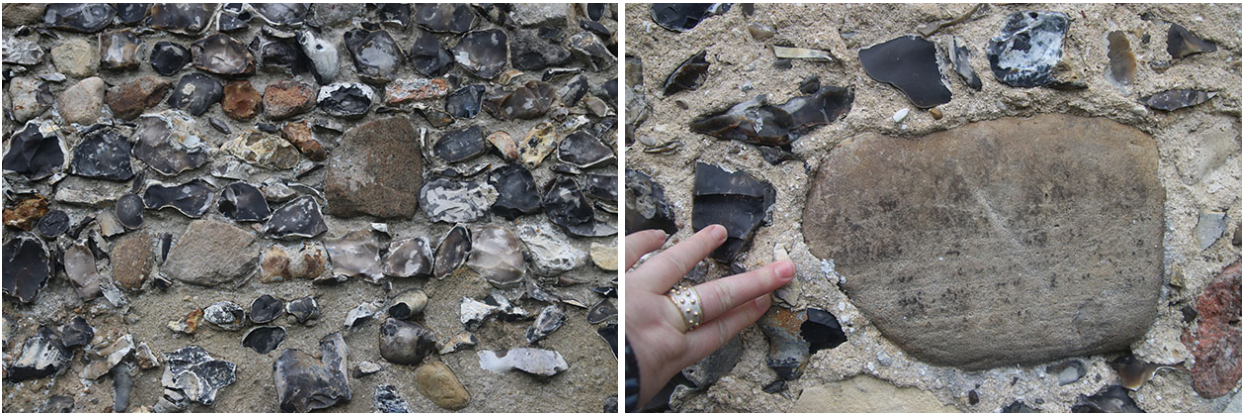
*Left & right: Knapped, coarse flints with boulders of brown arenaceous sandstone at St Mary's, South Walsham. The photo on the right shows a boulder which may show evidence of glacial striae.*

Exotic pebbles: sub-angular, brown, quartz arenites. These may be derived from the Crag or tills or could be ballast. Possibly striation on one example suggests till.

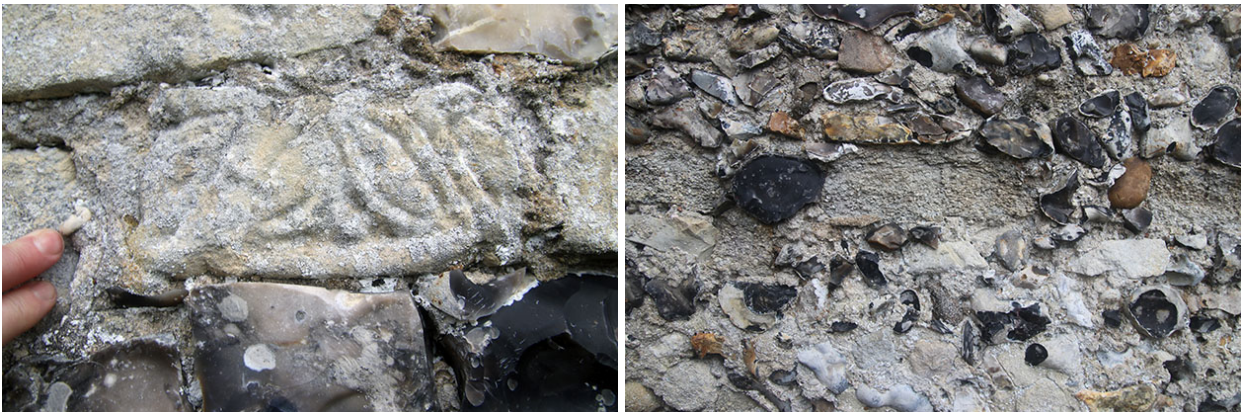
*Left: St Mary's Church, South Walsham. Fragment of carved capital in Caen Stone used as spolia in the church's fabric. Right: slabs of Purbeck stone, weathering in a line across the centre of the photograph.*

Lower courses (C12-13) of coarse flints with cortices intact, roughly coursed. Upper parts of knapped, uncoursed flint with spolia. The latter is composed of slabs of Purbeck Marble (much weathered, but with clear *Viviparus* sp., 10 cm thick, c. 30 cm long) occur about 1 m up from foundations in the south and east chancel walls. Also, a fragment of carved, spoliated capital in Caen Stone or Clunch to the west of the down pipe of the buttress between the nave and chancel on the south side.

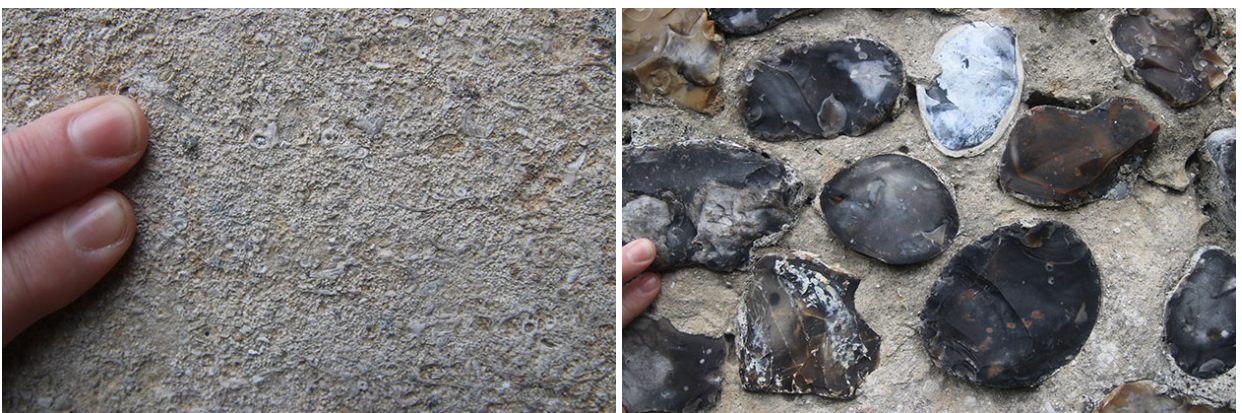
*Stonework at St Lawrence's, South Walsham. Left: detail of Clipsham Stone dressings; this cross-bedded calcarenite is packed with shell fragments. Right: Knapped flint cobbles.*

Knapped, uncoursed flint work with Clipsham Stone dressings.

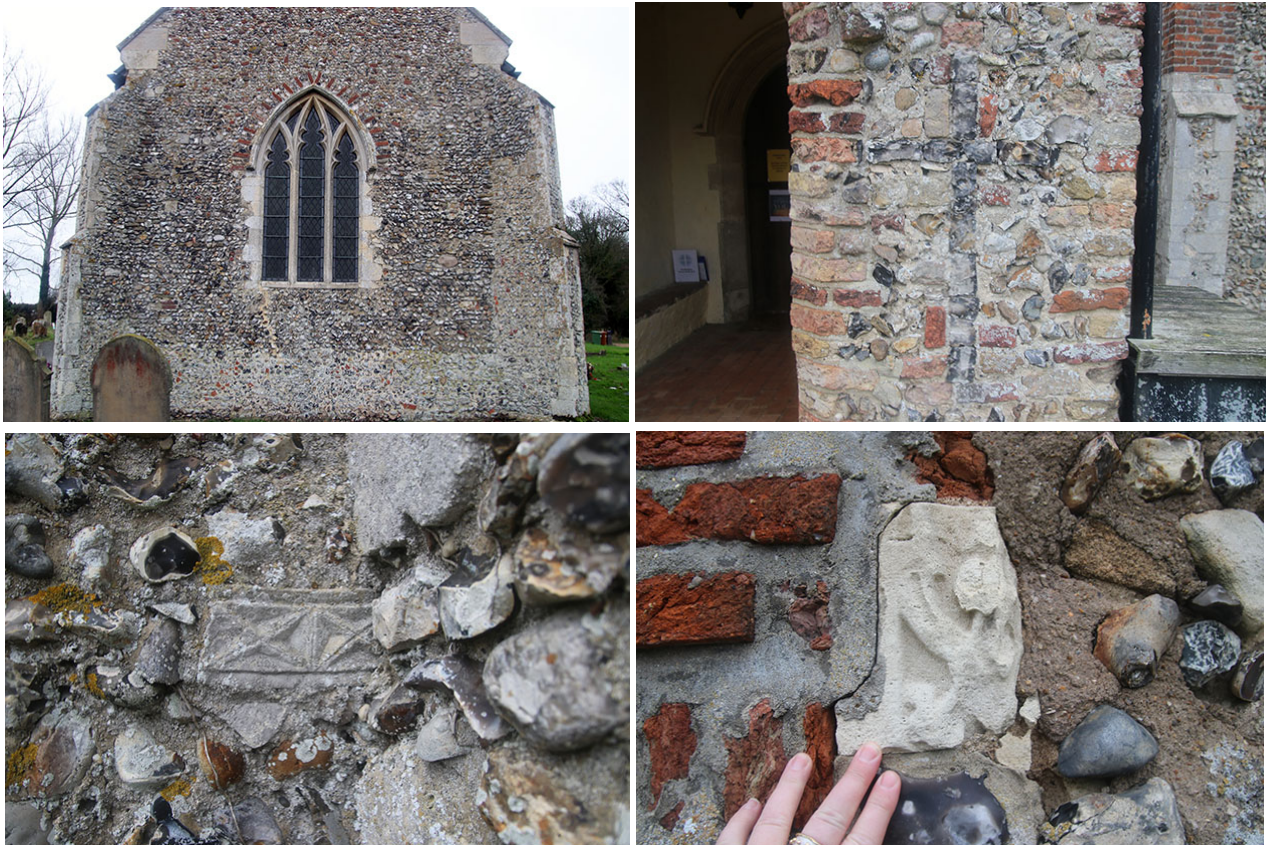
*Top left: The east end of All Saints Church, Hemblington showing at least two phases of construction. Top right: flushwork flint crosses in the brick-built south porch. Bottom left: Carved spolia and rough flints in the walls. Bottom right: Carved spolia in Caen stone. This is the remains of a window sill which has been cut into by Tudor brick work (on the left of the image).*

Abundant spolia in Caen Stone is present. The Tudor brick window on the tower is cut into what was probably a spoliated window sill in Caen Stone. There is also a large amount of brick and tile incorporated into the walls.

Flushwork, knapped flint crosses on either side of the south porch entrance.

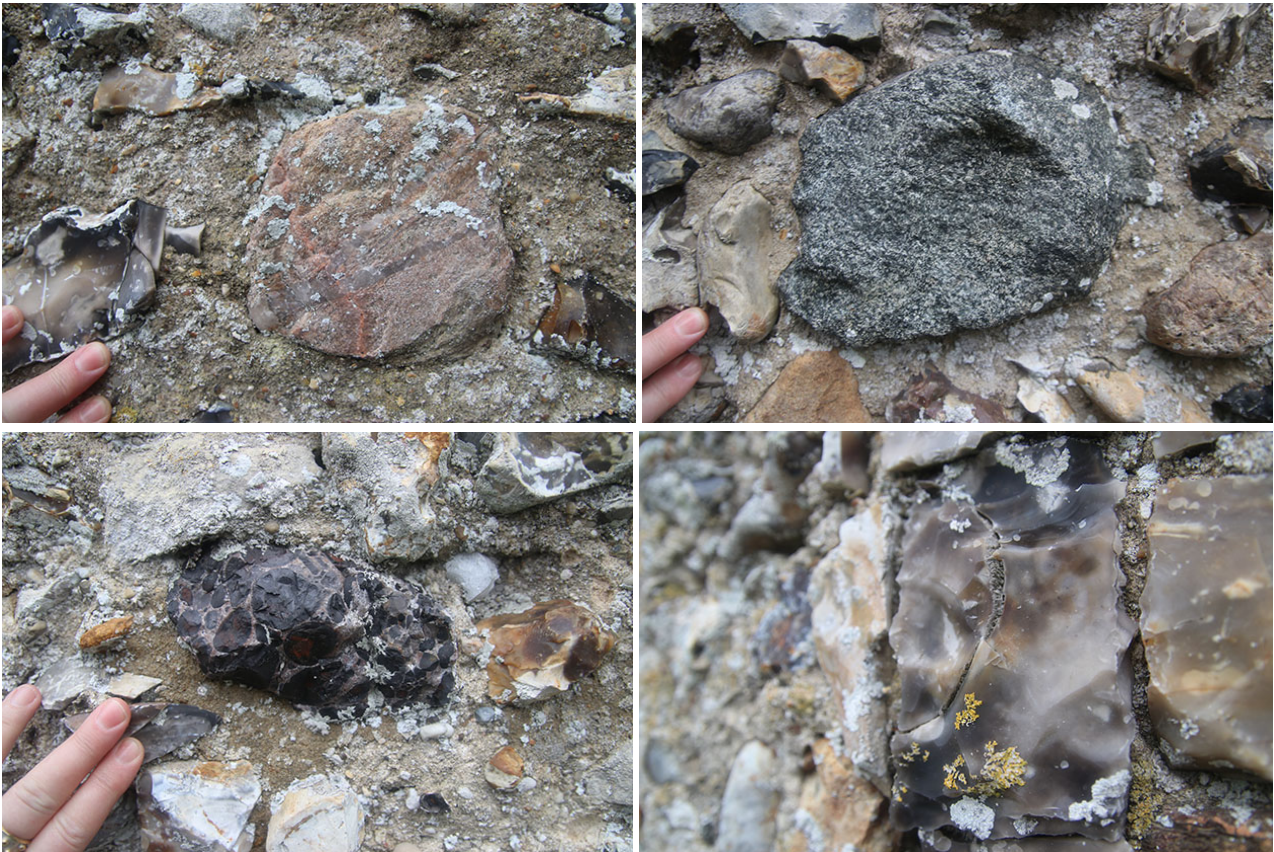
*Detail of stones at All Saints Church, Hemblington. Top left: Triassic quartzite split pebble. Top right: A medium grained diorite of unknown origin. Bottom left: Hertfordshire puddingstone, a form of sarsen. Bottom right: knapped flint with the trace of a fossil echinoid.*

Exotic cobbles: Abundant, well-rounded quartzite (Triassic) pebbles and also sub-rounded to sub-angular cobbles of brown arenaceous sandstones, probably from Wroxham Crag and related deposits. Also a few one-off finds i.e. Hertfordshire Puddingstone sarsen, a medium-grained diorite.
